DEPARTMENT OF TRANSPORTATION**DIVISION OF ENGINEERING SERVICES**

Contract #: 04-0120F4Cty: SF/ALA Rte: 80 PM: 13.2/13.9File #: 69.28**WELDING INSPECTION REPORT****Resident Engineer:**Pursell, Gary**Address:** 333 Burma Road**City:** Oakland, CA 94607**Report No:** WIR-000423**Date Inspected:** 08-Sep-2007**Project Name:** SAS Superstructure**OSM Arrival Time:** 2330**Prime Contractor:** American Bridge/Fluor Enterprises, a JV**OSM Departure Time:** 800**Contractor:** Zhenhua Port Machinery Company, Ltd (ZPMC), Changxing Island **Location:** Shanghai, China

Bridge No: 34-0006**Component:** Caltrans Mock Up**Summary of Items Observed:**

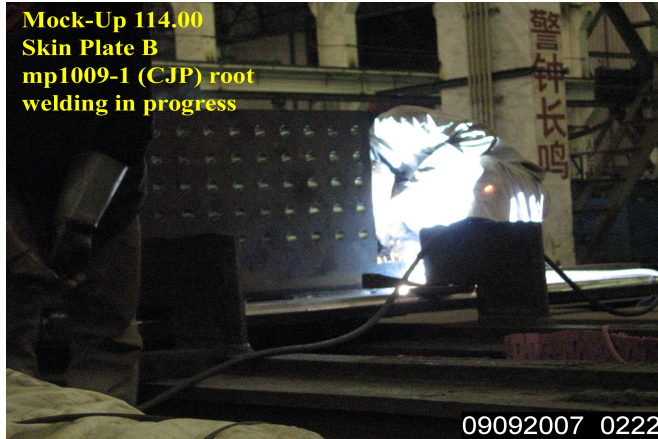
Mock-Up 114.00, skin plate B Assembly (Lower Section): Caltrans QA Inspector observed flux cored arc welding (FCAW) in progress at stiffener plate, mp1006-1 and mp1009-1 to skin plate MA102. The weld joints are identified as MUSA-MA102-3, 4, 5, 6, 7 and 8, complete joint penetration (CJP) and partial joint penetration (PJP), double bevel T-joint. The welder is observed welding root pass weld in the horizontal position and chipping and wire brushing during interpass weld cleaning. The approved welder is identified as Mr. Heng Feng, welder stamp 066421. The welder is using welding procedure specification WPS-B-T-2232-TC-U5-F, Revision 1 and WPS-B-T-2332-TC-P5-F, Revision 0. Caltrans QA observed ZPMC Quality Control (QC) Certified Welding Inspector (CWI) Mr. Lu Jian Ping and Bureau Veritas inspector, Mr. Li Gang monitoring welding activities at the workstation. Caltrans QA measured current welding parameters at approximately 290 amps, 29 volts and 240 millimeters per minute (mm/min) travel speed. Preheat and interpass temperatures were verified during welding activities. The preheat temperature prior to the start of welding measures more than 110 Celsius (230 degree Fahrenheit) but less than 232 Celsius (450 degrees Fahrenheit) during maximum interpass temperature verification. FCAW welding consumable is verified and identified as Supercored 71H, classification E71T-1, diameter 1.4 mm (.055 inches). Following digital picture illustrates welding in progress.

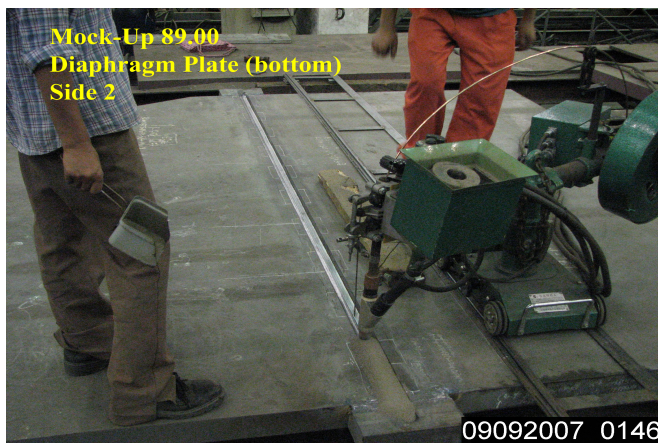
Mock-Up 89.00, Diaphragm (bottom plate): Caltrans QA Inspector observed submerged arc welding (SAW) in progress at plate splice weld, piecemark, P213 to P1235. The welder operator is observed welding a complete joint penetration (CJP) fill pass weld in the flat position. The assembly was then partially welded out from one side and then flipped over and welded from the other side, per fabrication procedure, welding sequence requirement. The welder is identified as Mr. Wu Zhi Bin, welder stamp 048904. The welder is using welding procedure specification WPS-B-T-3221-B-U3c-S, Revision 1. Caltrans QA measured current welding parameters at approximately 610 amps, 30 volts and travel speed, 460 millimeters per minute (mm/min). Preheat and interpass temperatures were verified during welding activities. Preheat temperature prior to the start of welding measures more than 180 degrees Celsius (350 degree Fahrenheit) but less than 232 degrees Celsius (450 degrees Fahrenheit) during maximum interpass temperature verification. SAW consumables were verified and identified as LA85, classification ENi5, diameter 4.8 mm (.189 inches) electrode and, Mil800-HPNi, classification F9A4 flux. Following digital picture illustrates welding in progress.

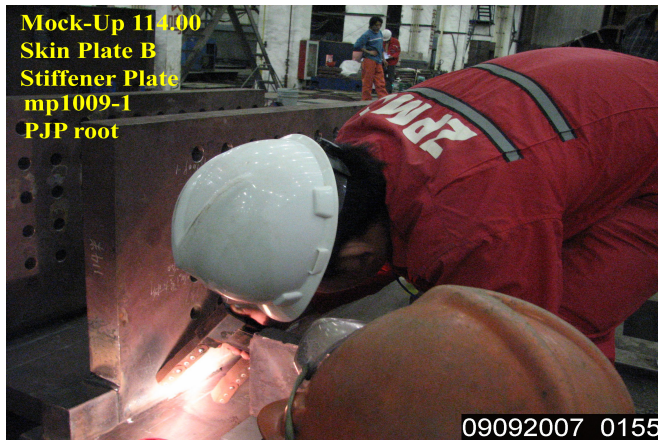
Caltrans QA Inspector witnessed ZPMC QC nondestructive (NDT) technician, Mr. Cai Xin Xin perform magnetic particle testing (MT) and Visual Testing (VT), at mock-up 114.00 skin plate B. The testing was performed on stiffener plate, mp1009-1, mp1006-1 to skin plate MA102, weld number MUSC-MA102-4, 5, 7 and 8, root pass weld. ZPMC inspection coverage appeared to be one-hundred percent of the weld, 535 mm in length. The testing appeared to be in general conformance with AWS D1.5 2002 requirements. At the conclusion of the MT testing, QC-MT nondestructive technician, Mr. Cai Xin Xin reported that root pass welds were found acceptable. Following digital pictures illustrate MT in progress.
